The ECU+ Fuel/Timing/Datalogging Piggyback Engine Computer

Version 2.10 Upgrade Guide 07/24/07

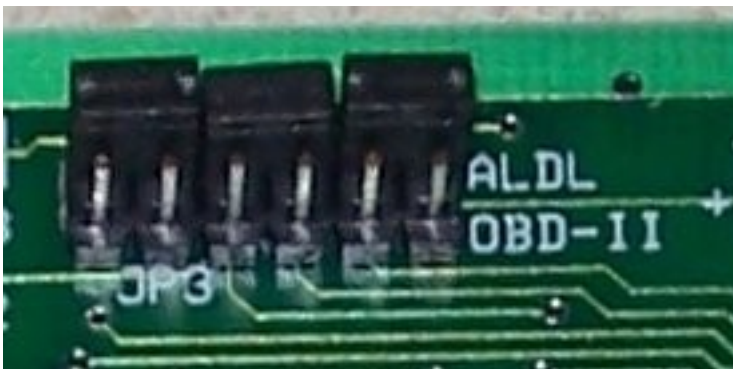
Illustration 3 - JP3 jumpers in ALDL mode (1G DSMs)

If you have a 2G DSM or EVO stock ECU, no changes to these jumpers need to be made. If your stock ECU is from a 1G DSM, you'll need to alter the JP3 jumper configuration to use *ALDL* mode. The figures below illustrate the jumper configuration for the two modes.

1. *ALDL* mode, used for the 1G DSMs.
2. *OBD-II* mode, used for the 2G DSMs and the EVOs.

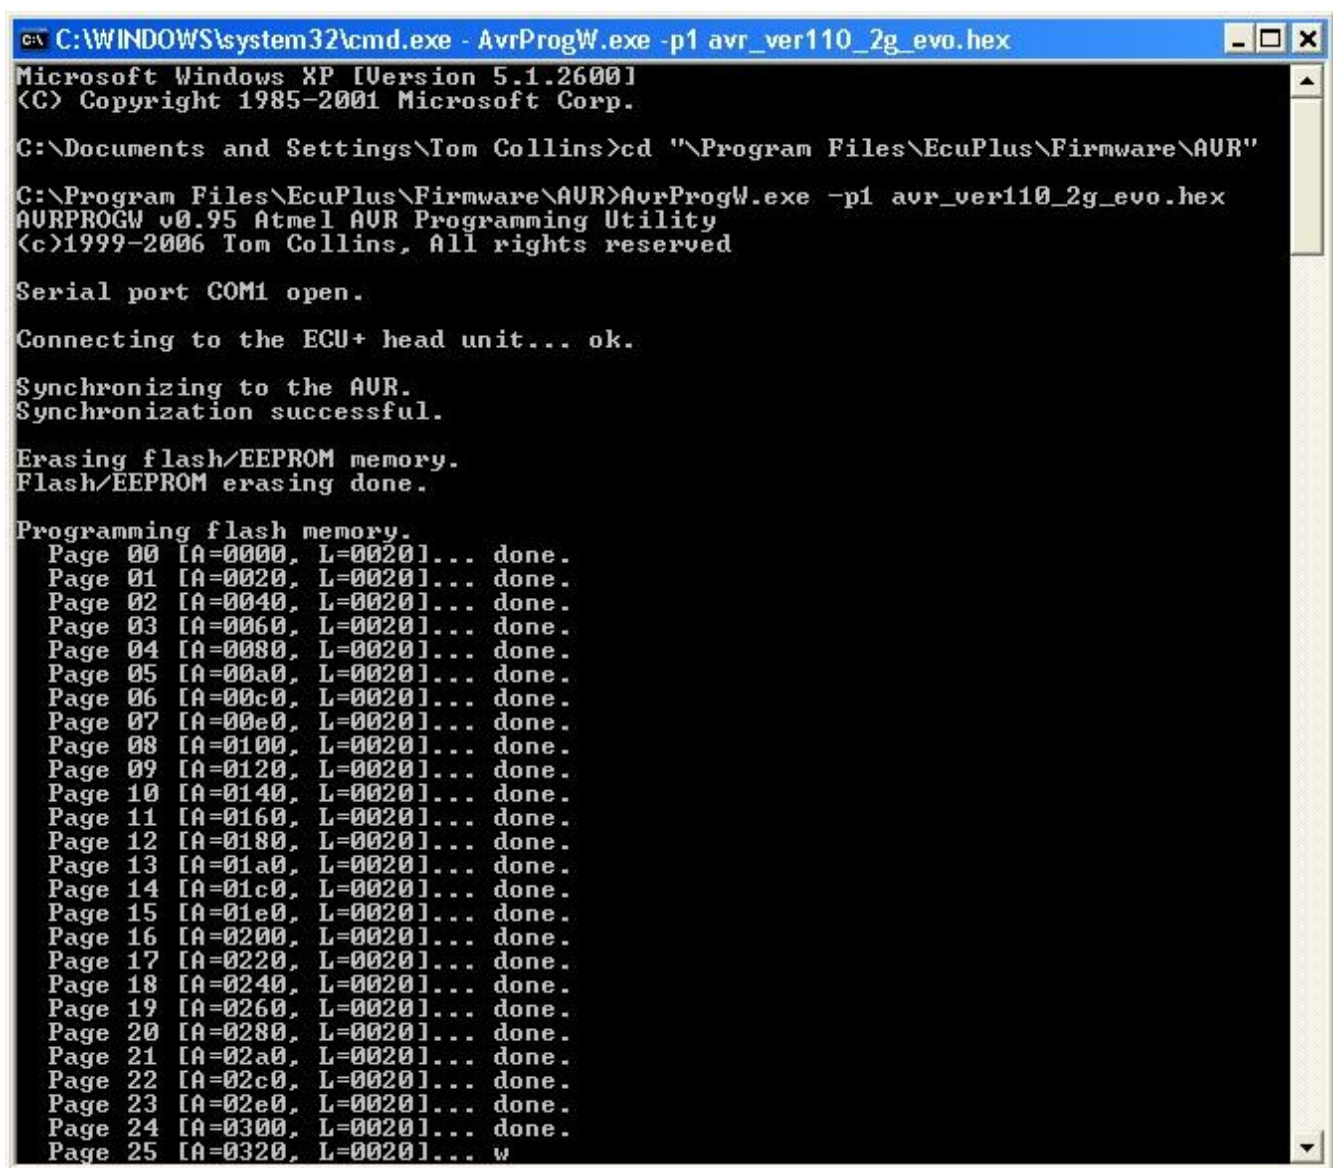
The firmware upgrade should complete without error. A sample screen is shown below.

```
C:\WINDOWS\system32\cmd.exe - AvrProgW.exe -p1 avr_ver110_2g_evo.hex
Microsoft Windows XP [Version 5.1.2600]
(C) Copyright 1985-2001 Microsoft Corp.

where <filename> is avr_ver110_1g.hex for the 1G DSMs or avr_ver110_2g_evo.hex, and the -p1 signifies that your laptop's COM1 port is connected to the ECU+ head unit. (Use -p2 for COM2, and so on.)
